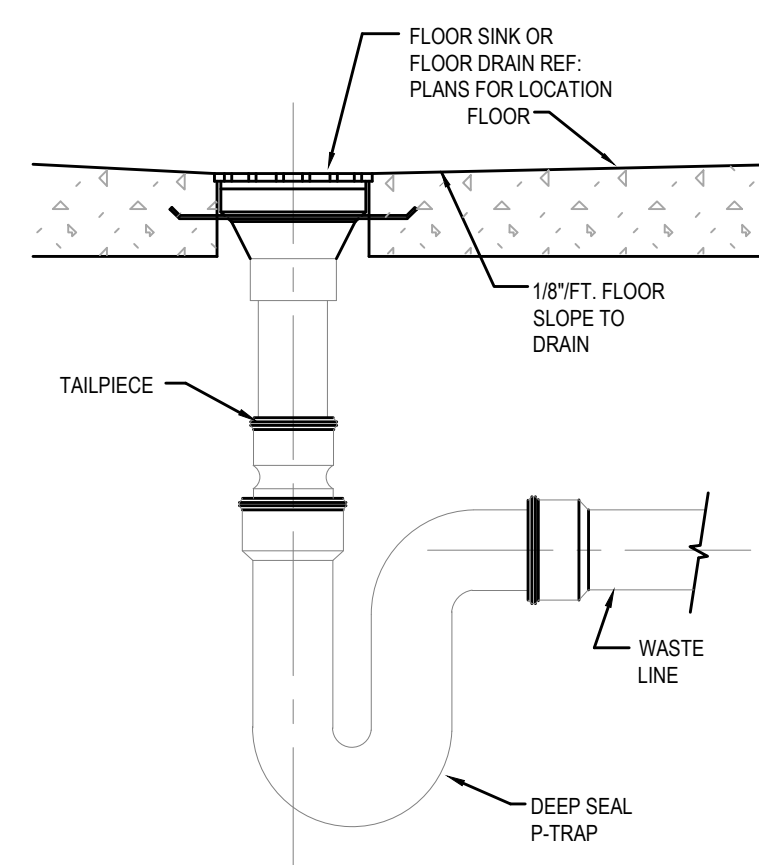
5 | TYPICAL FLOOR DRAIN/SINK
P7.1 | N.T.S.

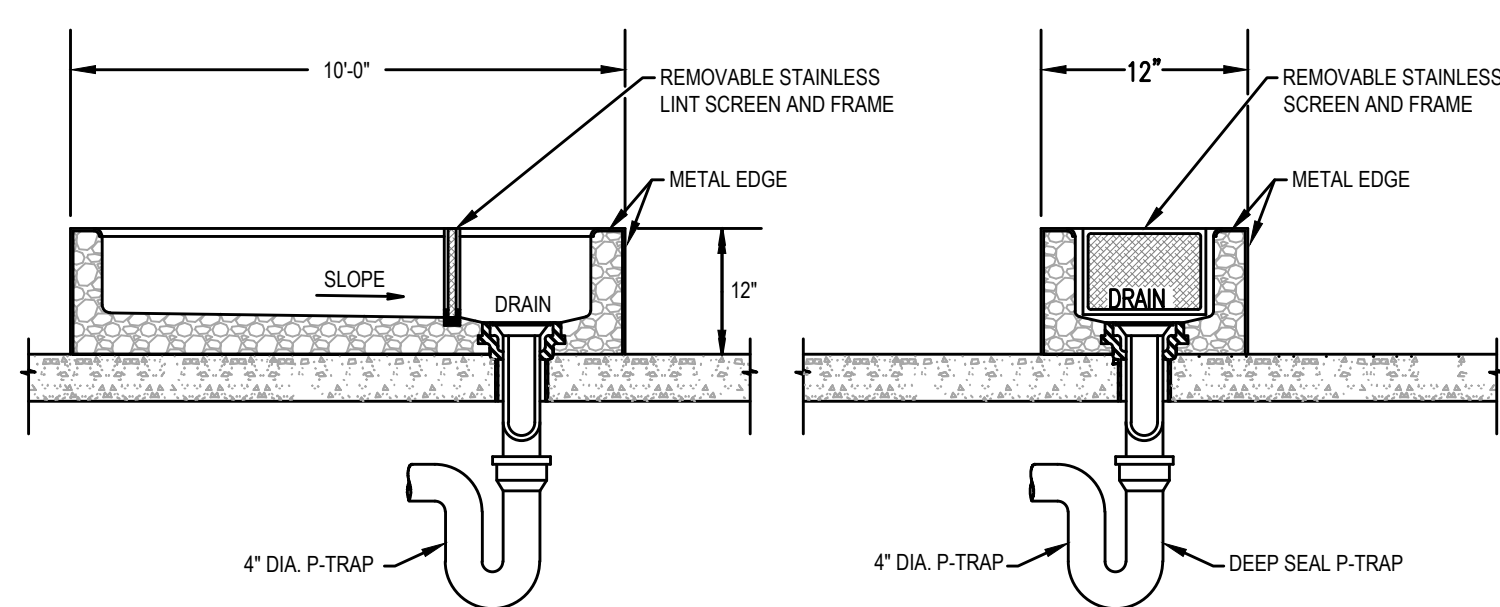
6 | LINT TRAP WASHING MACHINE DETAIL
P7.1 | N.T.S.

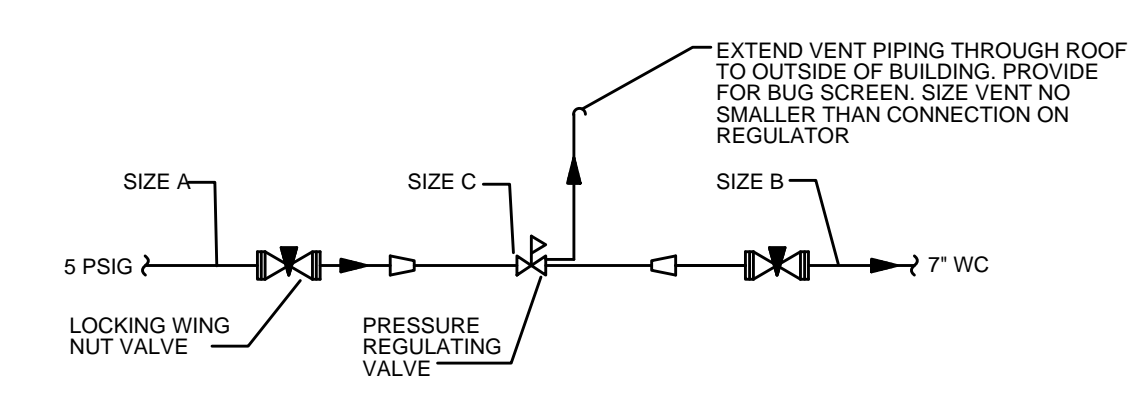
1 | GAS PRESSURE REGULATING STATION
P7.1 | N.T.S.
