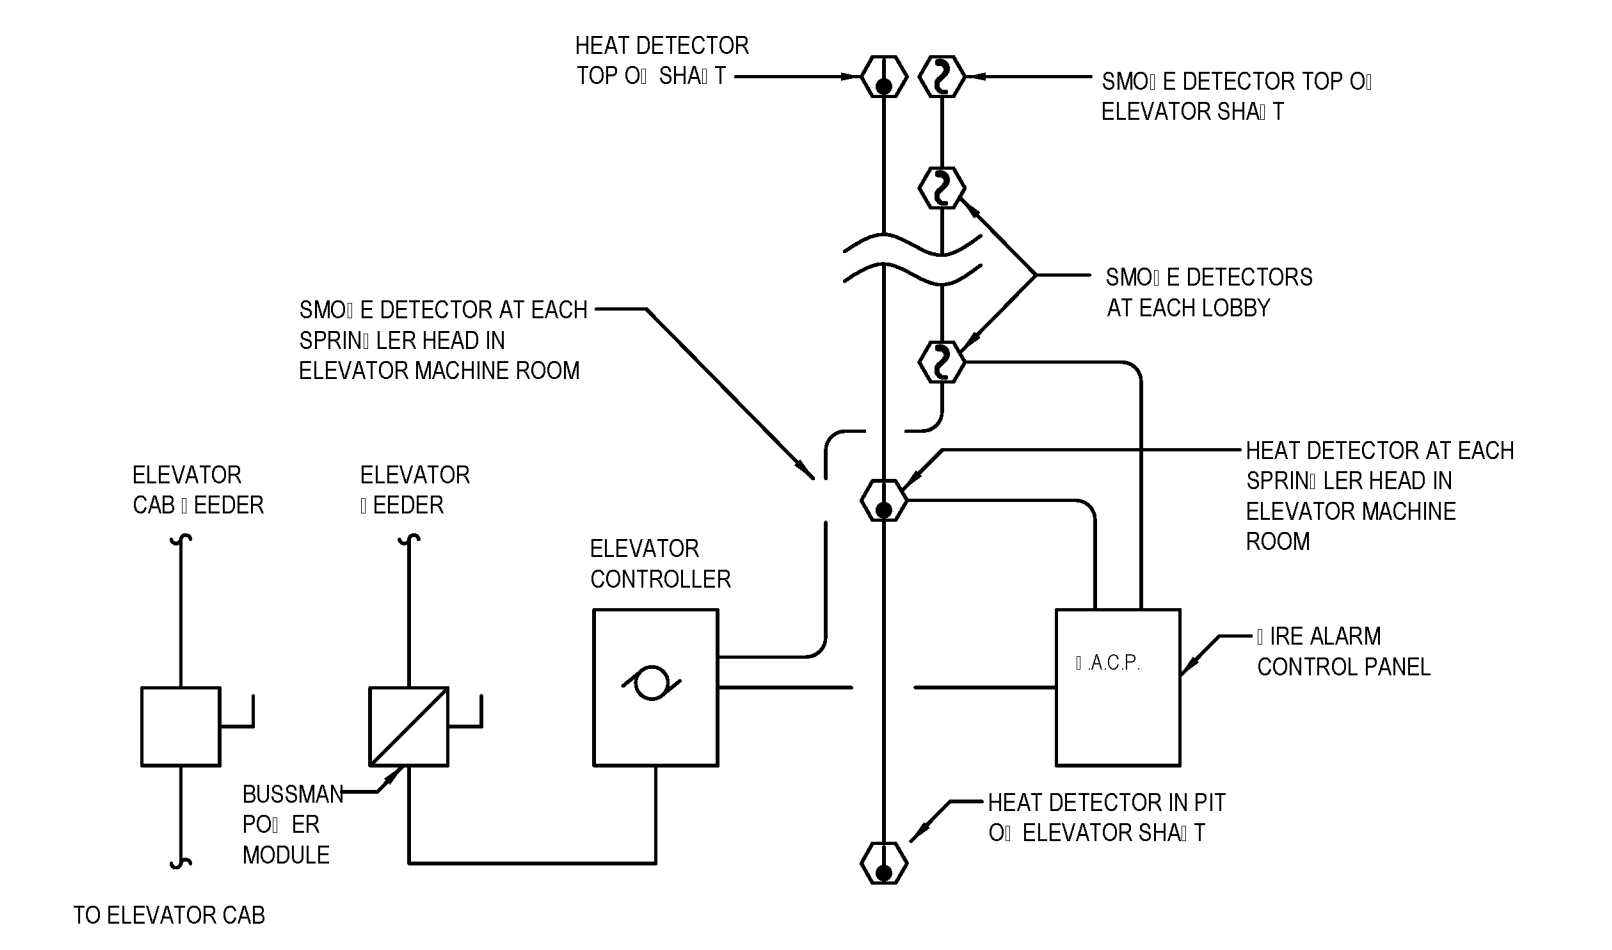
6 | ELEVATOR CONTROL SCHEMATIC  
E5.3 | NTS

- NOTES:
1. WIRING IS TYPICAL FOR EACH ELEVATOR.
  2. COORDINATE OPERATION OF ELEVATOR WITH AUTHORITY HAVING JURISDICTION OR USE AS A MEANS OF EGRESS.
  3. EACH SMO DETECTOR SHALL HAVE A CONTACT CONNECTED TO EACH ELEVATOR CONTROLLER IN THE BANK OF ELEVATORS.
  4. HEAT DETECTORS SHALL HAVE AUXILIARY CONTACT TO SHUNT TRIP ELEVATOR CONTROLLER POWER UPON ACTIVATION.
